- 1. **Smithsonian Trinomial:** 42GR2305
- 2. **Temporary Site No.:** R1
- 3. **Site Name:** Cottonwood Road (BLM Road 181)

- 4. **Date Recorded:** 09/01/2020
- 5. **Type of Recording:** First Recording Full Re-record Update
- 6. **Project Name:** A Cultural Resources Inventory of the Cisco Spring 2D Seismic Project in Grand County, Utah
- 7. **State Project Number:** U20HP0585
- 8. **Land Status:** BLM (Moab Field Office); Private
- 9. **USGS 7.5' Quad Map Name and Date:** Danish Flat (1970)
- 10. **Township:** 20 S, **Range:** 24 E, **Section(s):** 17, 18, 20 and 29, **(1/4):** Linear **County:** Grand

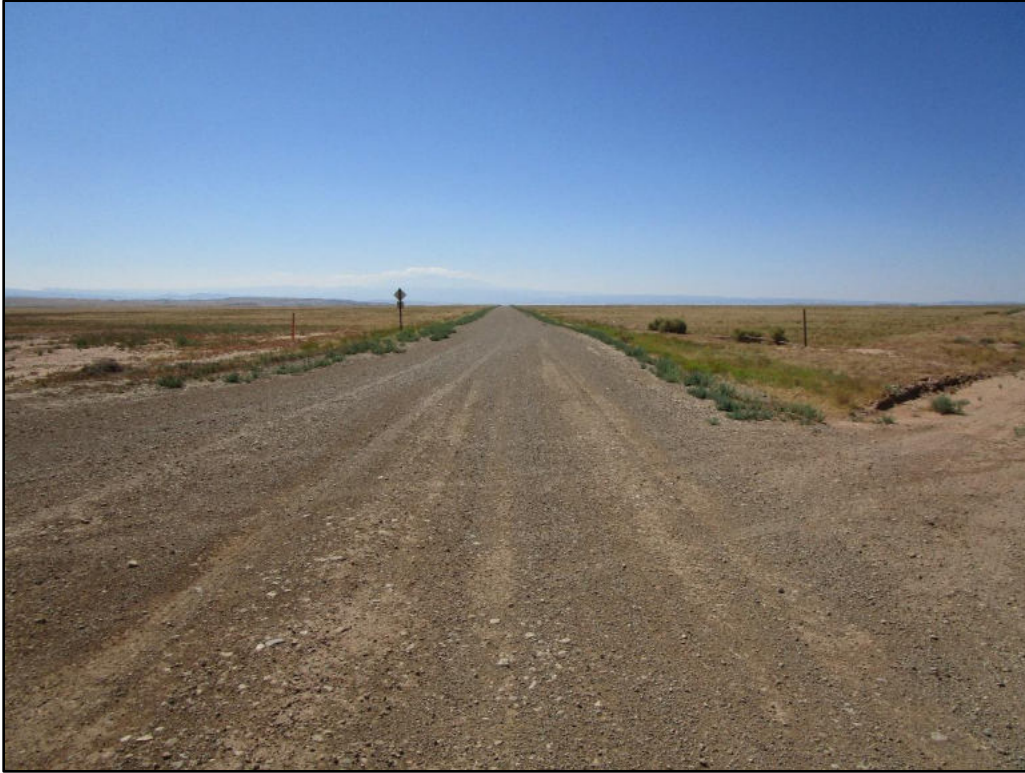
Site 42GR2305. Site overview from north end of segment at junction with Danish Flat Road (42GR7591); view to the south.

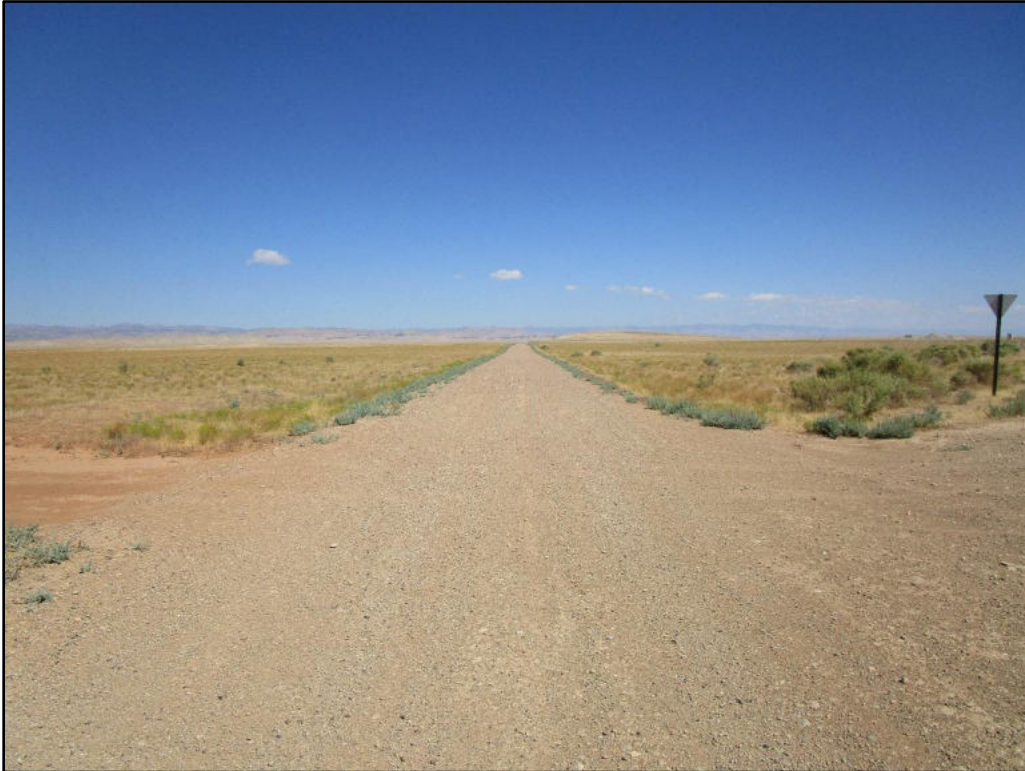
Site 42GR2305. Site overview from north end of segment at junction with Danish Flat Road (42GR7591); view to the north looking toward Book Cliffs.

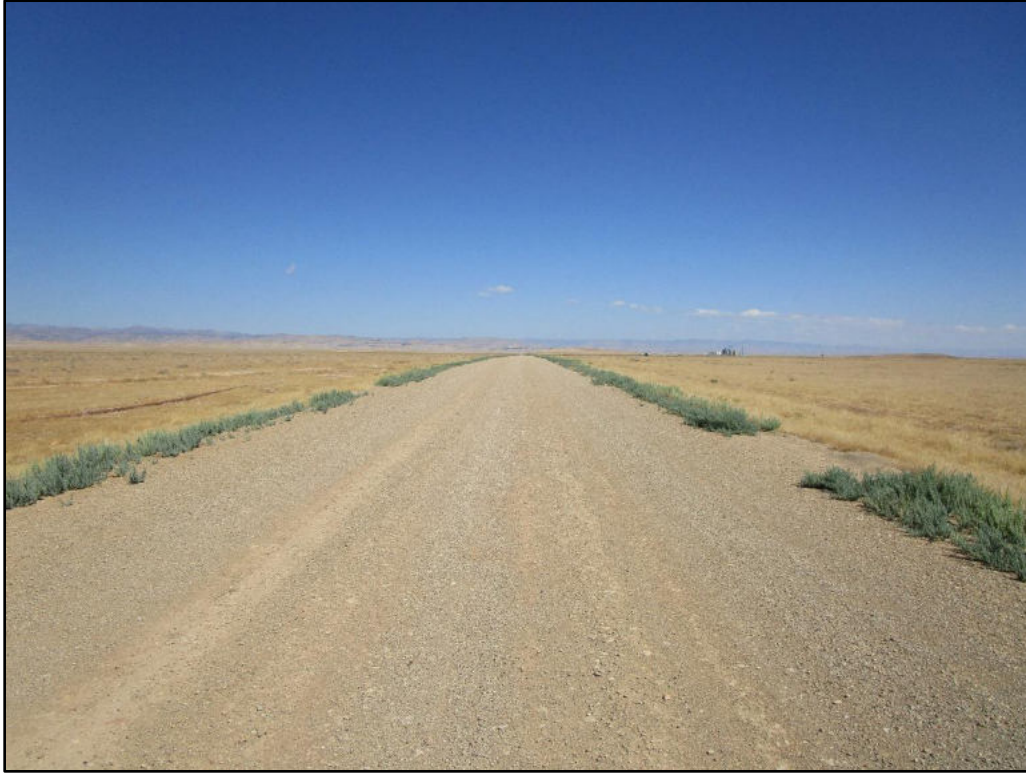
Site 42GR2305. Site overview looking north toward Danish Flat evaporation ponds; photo taken from survey line 12 (UTM 647519mE/4325576).

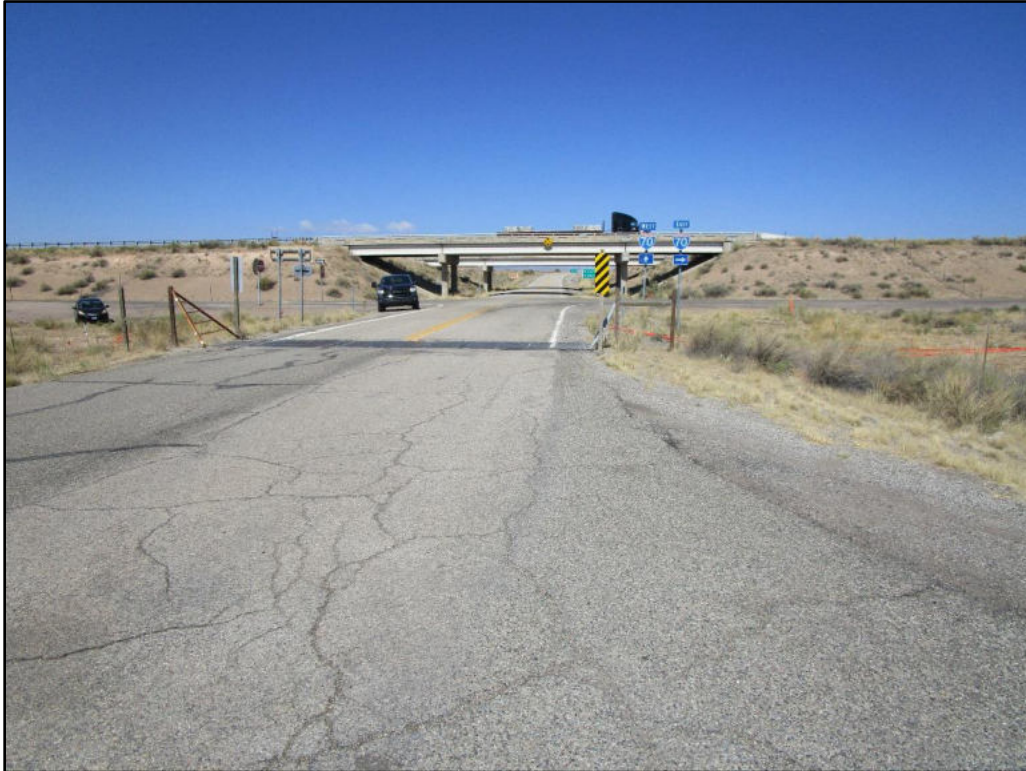
Site 42GR2305. Site overview from south end of road from SR 128 (Crescent to Cisco East Rd); view to the north showing I-70.
