UTAH ARCHAEOLOGY SITE FORM

- 1. **Smithsonian Trinomial:** 42GR935
- 2. **Temporary Site No.:**
- 3. **Site Name:** D&RGW Narrow Gauge RR

- 4. **Date Recorded:** August 18 and 25-30, 2020
- 5. **Type of Recording:** First Recording Full Re-record Update
- 6. **Project Name:** A Cultural Resources Inventory of the Cisco Spring 2D Seismic Project in Grand County, Utah
- 7. **State Project Number:** U20HP0620
- 8. **Land Status:** BLM (Moab Field Office); State (SITLA); Private
- 9. **USGS 7.5' Quad Map Name and Date:** Danish Flat (1970), Cisco (1970)
- 10. **Township:** 20S, **Range:** 24E, **Section(s):** 18 and 19, **(1/4):** Linear **County:** Grand
Township: 20S, **Range:** 23E, **Section(s):** 25 and 36
Township: 21S, **Range:** 23E, **Section(s):** 1, 11, 12, and 15

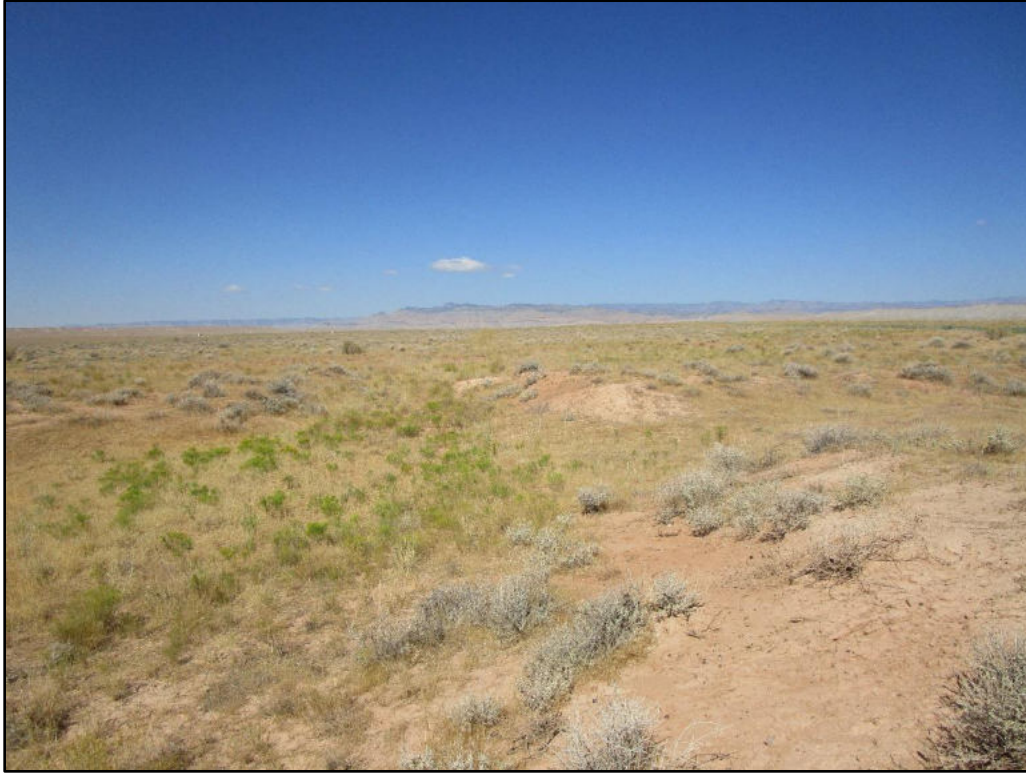
Site 42GR935. Site overview showing railroad berm at RR1 crossing. Cut in berm is historic *Cisco Springs Road* (42GR7592); view to the west.

ID	Location Description	UTMs (NAD83)	
		Easting	Northing
RR1	Location crosses a previously recorded segment (Montgomery). Revisit to this site observed as described. Includes sandstone culvert. The railroad berm in the area is extremely disturbed by road construction and oil & gas activity in the area. It is barely discernable at these crossings.	646311	4324438
RR2		346269	4324282
RR3	Smoothed and rounded berm	645977	4323166
RR4	Smoothed and rounded berm	645964	4323130
RR5	Smoothed and rounded berm	645819	4322997
RR6	Smoothed and rounded berm	645362	4322910
RR7	Smoothed and rounded berm, visible cuts through low hills	645462	4322627
RR8	Smoothed and rounded berm, visible cuts through low hills	645879	4322242
RR9	Smoothed and rounded berm, visible cuts through low hills	645663	4321852
RR10	Smoothed and rounded berm	645484	4321836
RR11	Smoothed and rounded berm	645080	4321414
RR12	Smoothed and rounded berm, visible cuts through low hills	645272	4320793

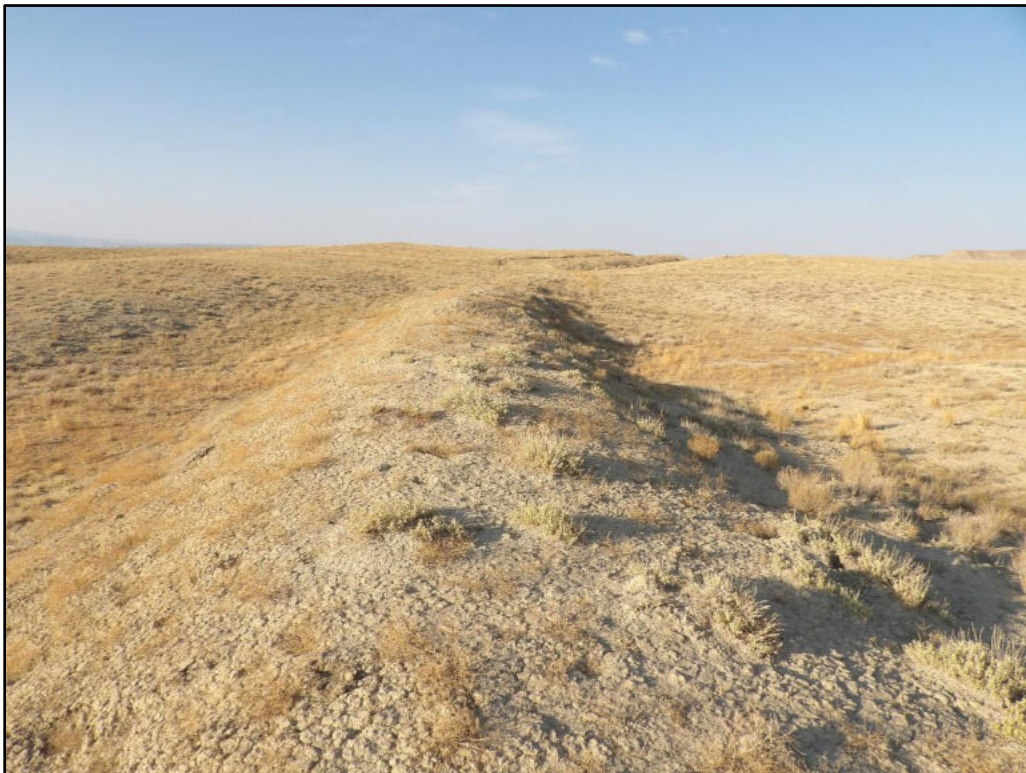
Site 42GR935. Representative site overview showing railroad berm at RR4 crossing; view to the south.

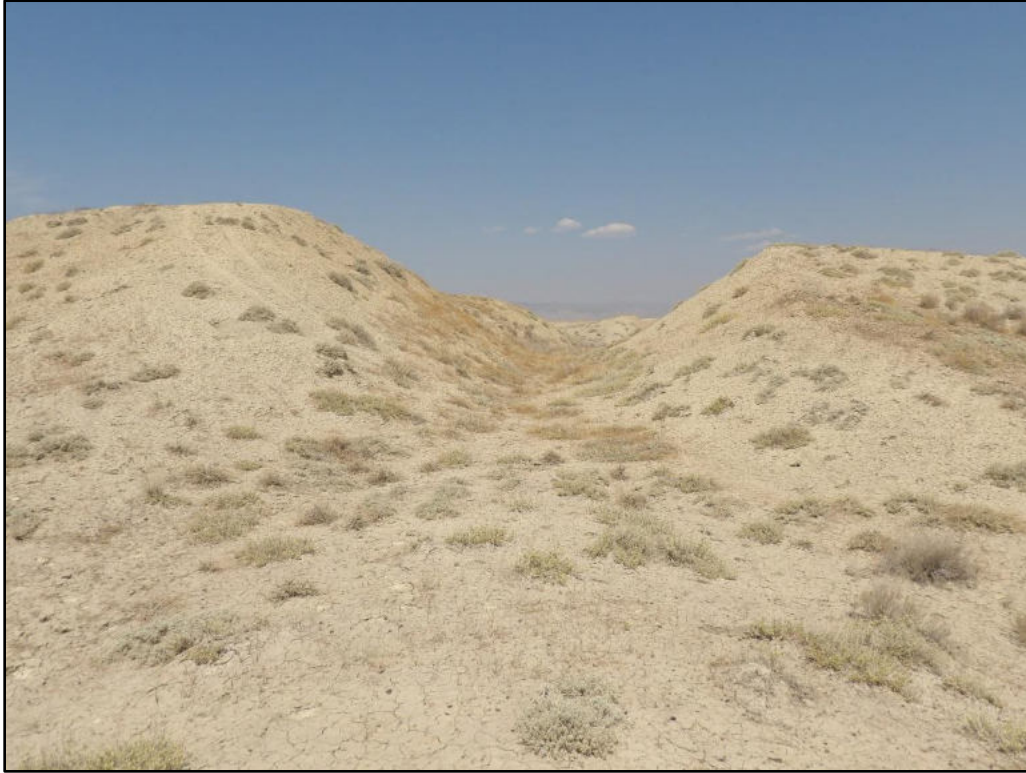
Site 42GR935. Representative cut in the rolling hills at RR7 crossing; view to the west.

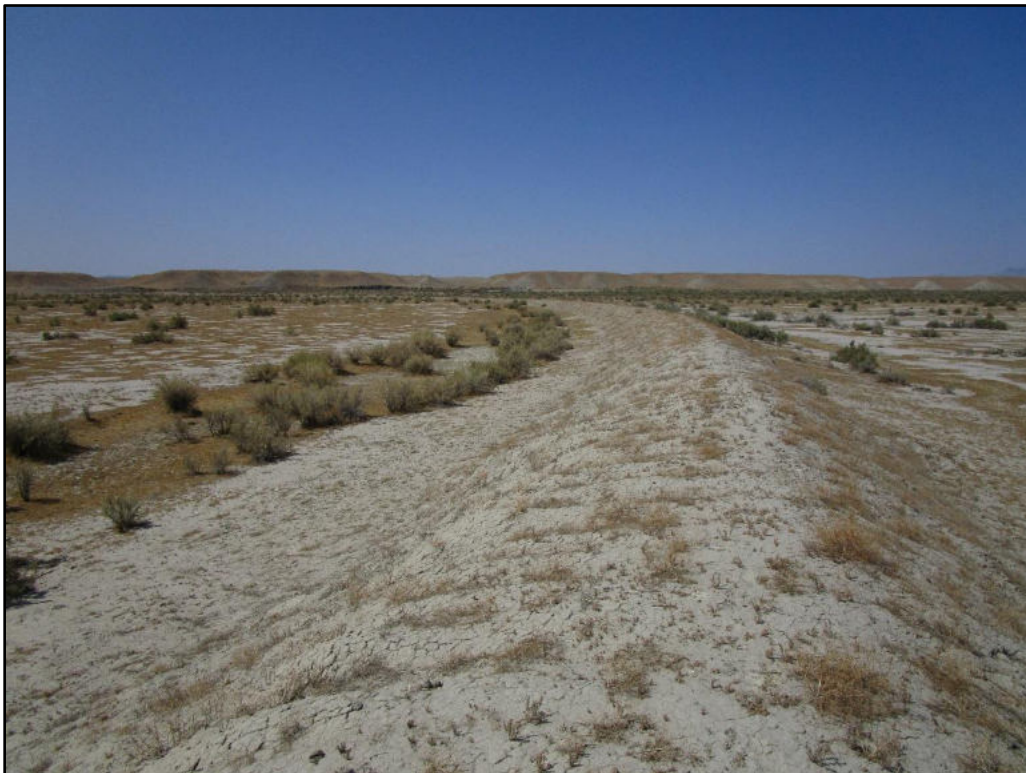
Site 42GR935. Representative site overview showing railroad berm at RR15 crossing; view to the west.

RR13	Smoothed and rounded berm, visible cuts through low hills	645648	4320366
RR14	Smoothed and rounded berm, visible cuts through low hills. Dirt road cuts through at this location	645644	4319542
RR15	At Cisco Wash. Smoothed and rounded berm, completely washed away in some areas. Berm is deeply cut and washed away completely in main wash channel to southwest.	642413	4316192
RR16		642166	4315937

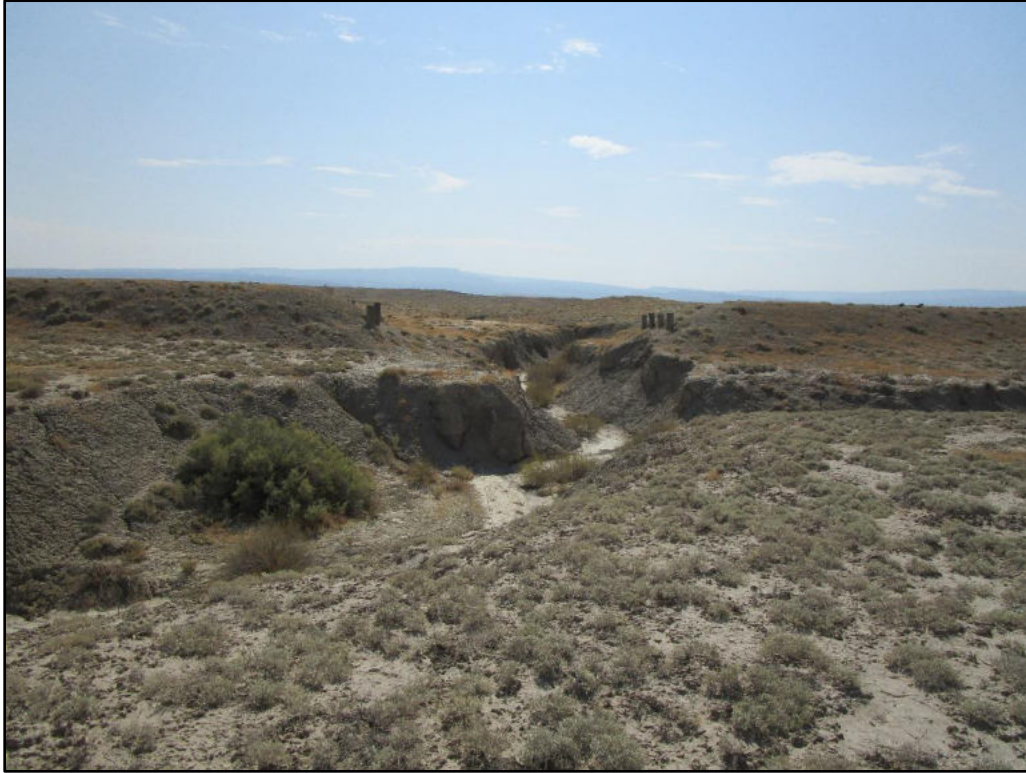
Site 42GR935. Site overview showing trestle footings visible outside of project area from survey line 17 at UTM 643293mE/4317011mN; view to the southeast.

- 5. **Feature Comments:** All segments of the railroad berm, which was crossed 16 times at different locations during the survey of the seismic lines for the current project, consist of a low berm or shallow linear depression in the project area. No features were observed within the survey area. Two features in the area are visible from the survey lines, including a large sandstone culvert and the footing for a trestle. These features were both previously recorded and described (Montgomery 1994; Russell 2008).

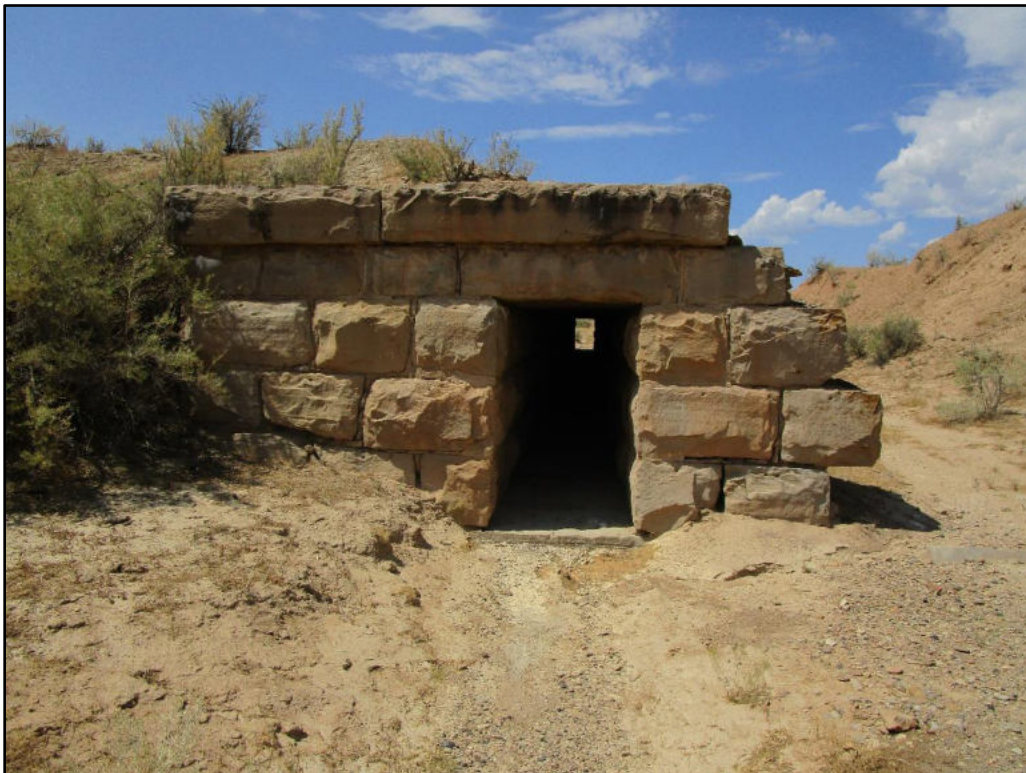
Site 42GR935. Site overview showing sandstone culvert visible outside of project area from survey line 12 at UTM 646221mE/4324017mN; view to the west.
